ANILOX ROLL QUALITY CONTROL REPORT

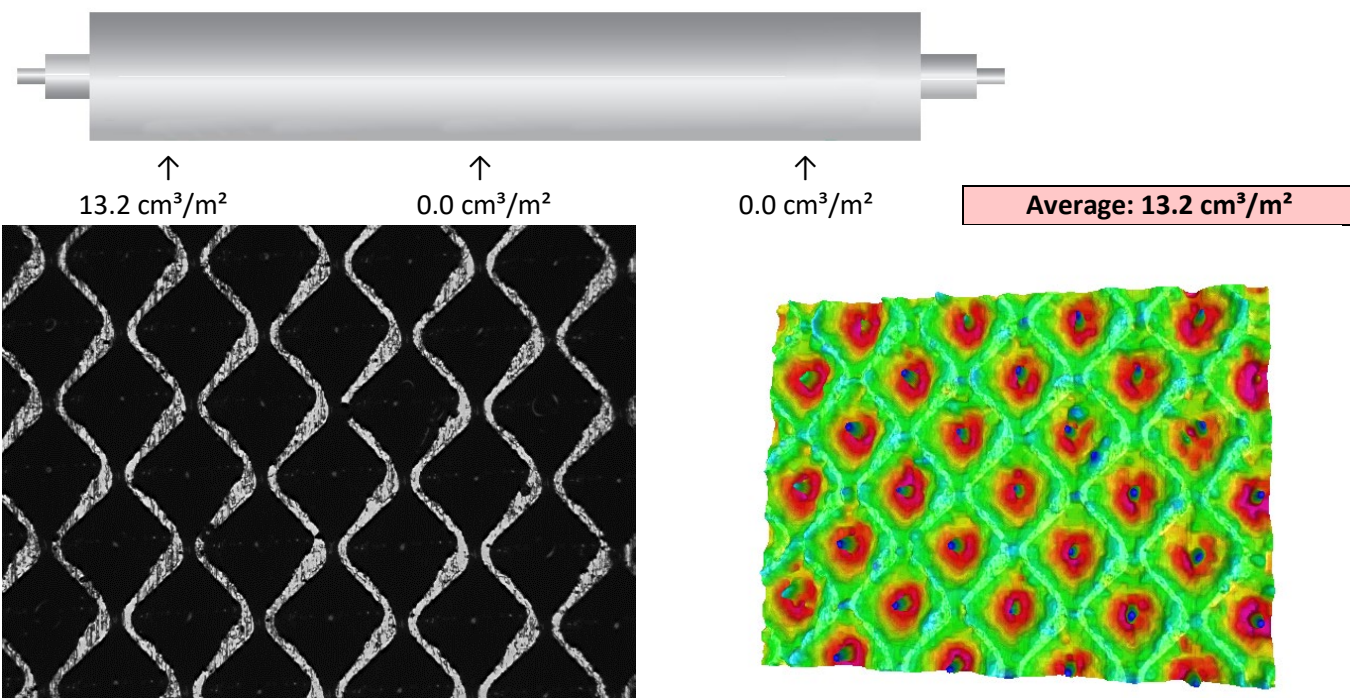
Roll Information, before cleaning.

Screen condition: Excellent Good Fair Poor Extremely bad

Remarks: Scorelines metal calcium damages undercorrosion

Cell Info: **Opening:** μm **Wall:** μm **Depth:** μm

Extra action needed: **CLEAN MINIMUM 4 x per year to avoid damages to cell walls!!! Lot of scratches and small damages!**

- Monitoring each month / Doctor Blade chamber check / Calcium treatment / Emergency kit
 Magnet and filter to prevent score lines / heating tank treatment / worn check by AniCAM

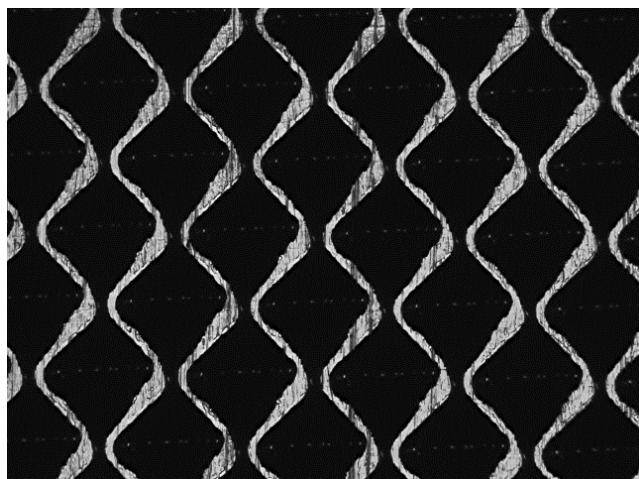
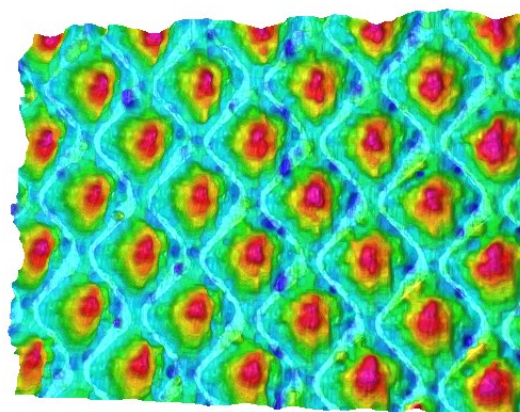
Roll Information, after cleaning.

Cell Info: Opening: μm Wall: μm Depth: μm

↑
18.3 cm^3/m^2

↑
0.0 cm^3/m^2

Average: 18.3 cm^3/m^2
(38.6%)

Advise for renewal months: < 3 < 6 12 > 12 no need

Advise Cleaning Liquid: **BIOCLEAN GLUEROLL CLEANER**
